DEPARTMENT OF CONSERVATION

OFFICE OF MINE RECLAMATION

California's Abandoned Mine Lands Program Fact Sheet Abandoned Mine Inventory and Remediation

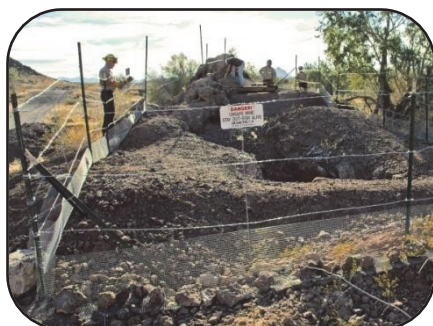
Fence, Imperial Co.

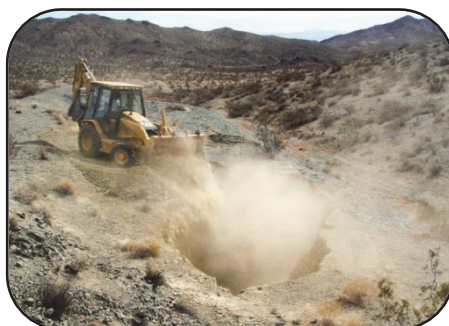
Backfill, San Bernardino Co.

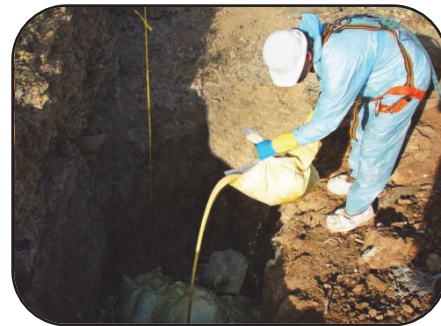
PUF closure in progress, Inyo Co.

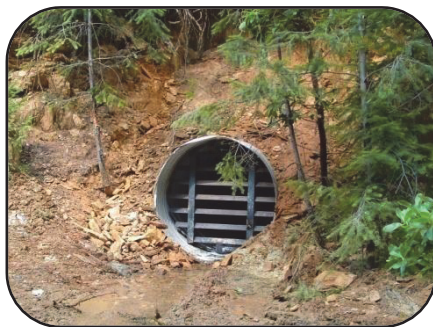
Culvert gate, El Dorado Co.

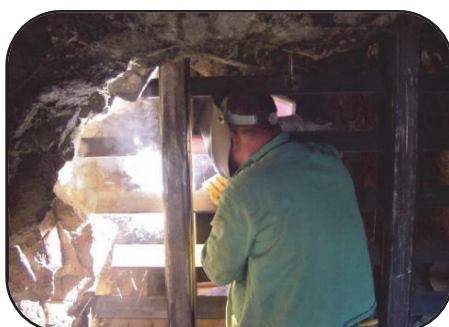
Bat gate in progress, Riverside Co.

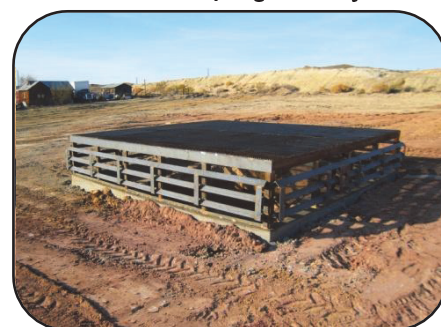
Bat cupola, Kern Co.
